**TNO report****DV2 2005-A13****Analysing blast and fragment penetration effects  
on composite helicopter structures**

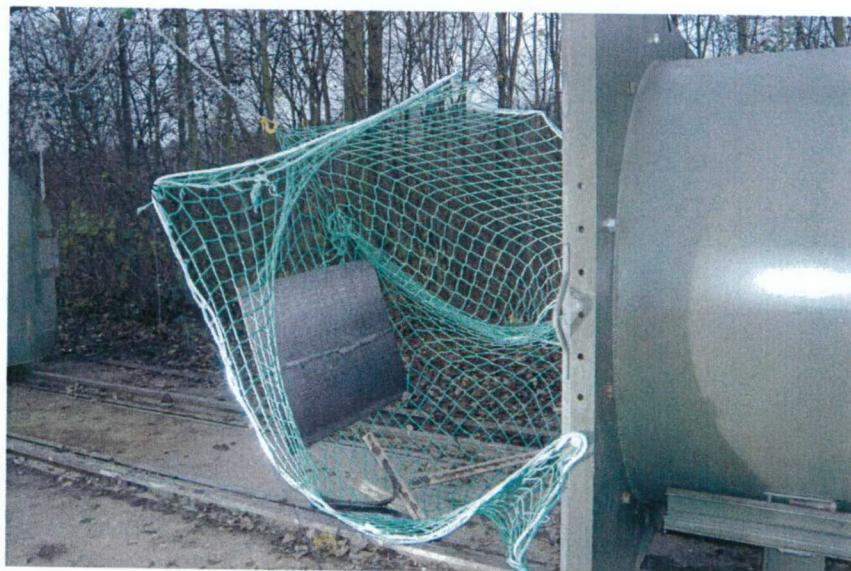
Figure 9      Panel 2 is nicely caught by the safety net.

In this test the panel initially bent globally, then folded and subsequently released from its supports, see also the sequence in Figure 10. Afterwards, the panel was nicely caught by the safety net, as can be seen in Figure 9.

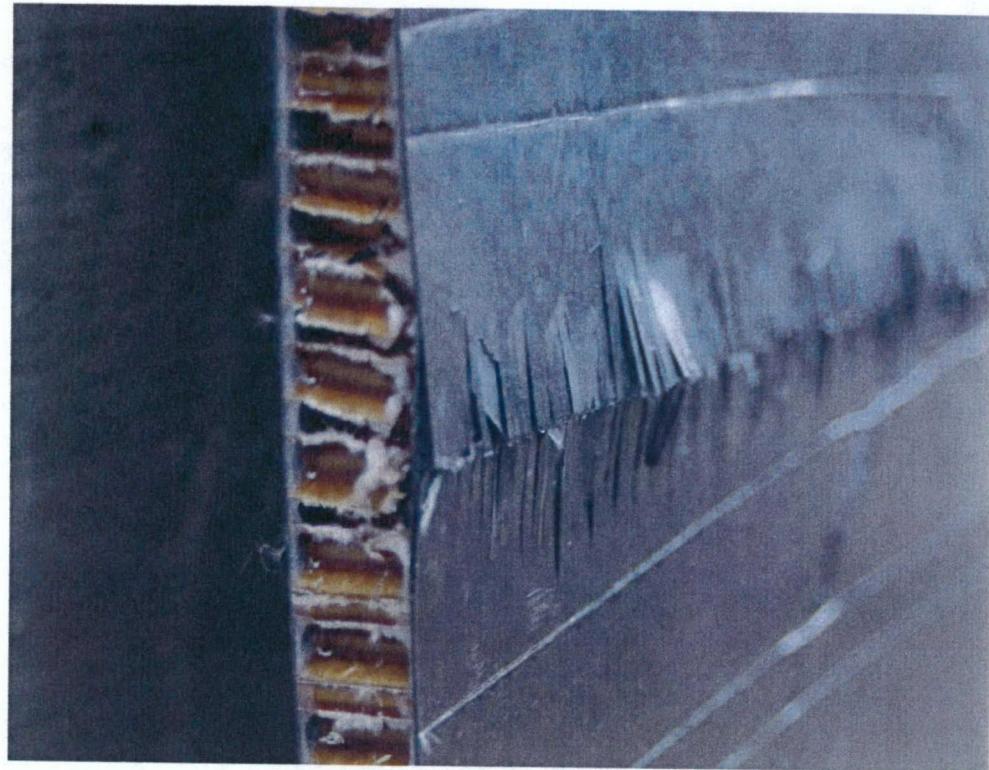
At the ends of the main 'fold', the damage of the honeycomb is visible. Delamination between facing and honeycomb seems to have occurred, but at one side also in-plane 'cracks' are observed in the honeycomb. To be able to fold during flight, the honeycomb has to be locally crushed. This clearly happened; the honeycomb lost its stiffness almost completely.

Figure 13 Honeycomb damage at the end of the main fold. In-plane cracks and local delamination and crushing are observed.

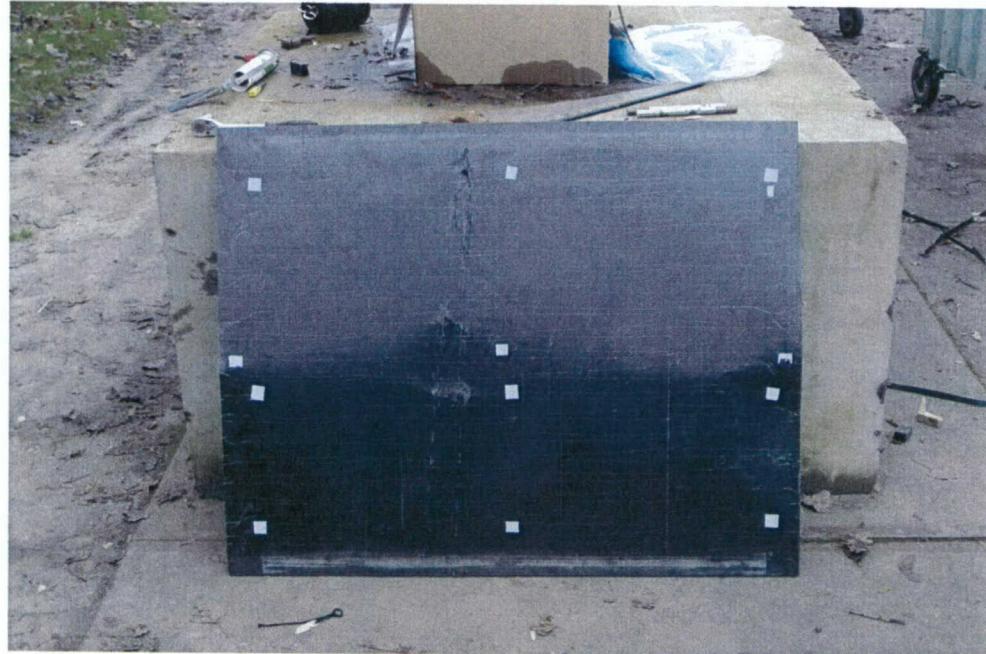
Figure C.1 Unloaded panel side with large indentation by the chain used to tighten the safety net.

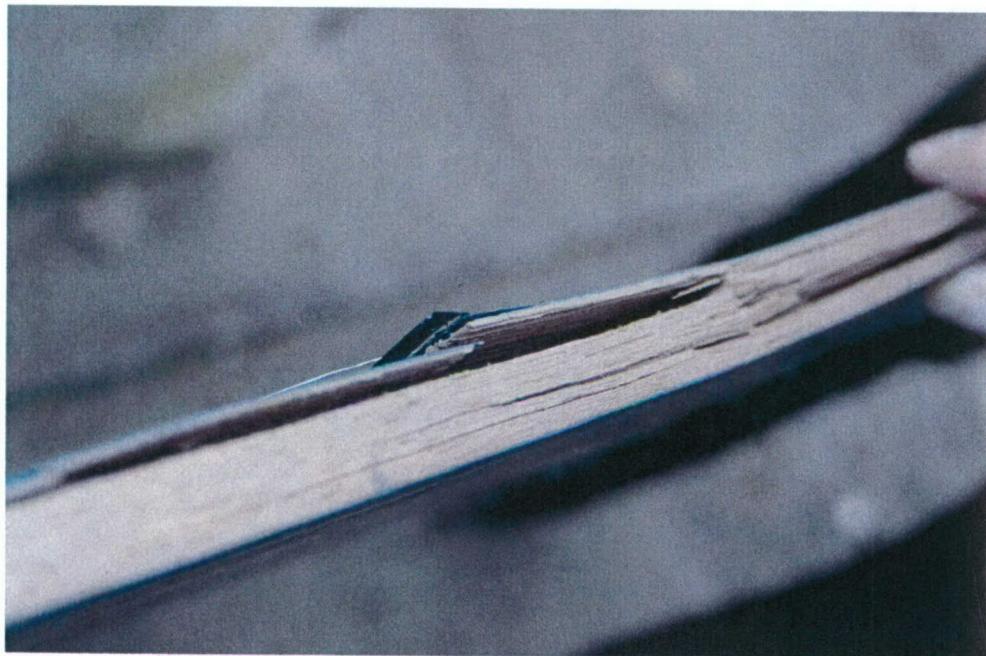
Figure C.2 Delaminated wooden insert and teared facing.

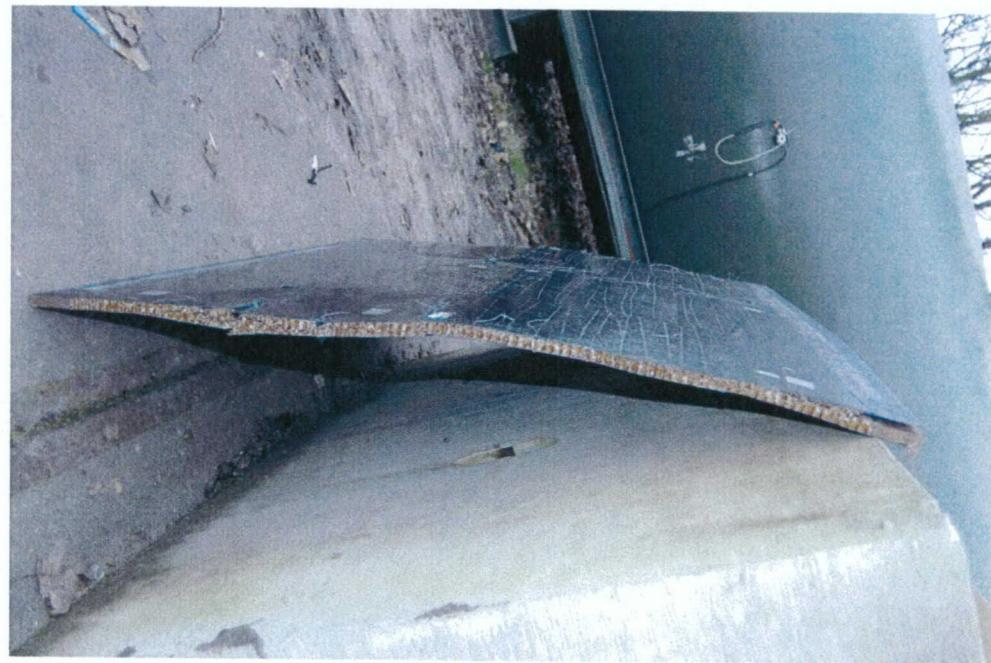
Figure C.3 Side of panel 1 after test 2. From left to right, the details follow in in the Figure C.4 to Figure C.7 below

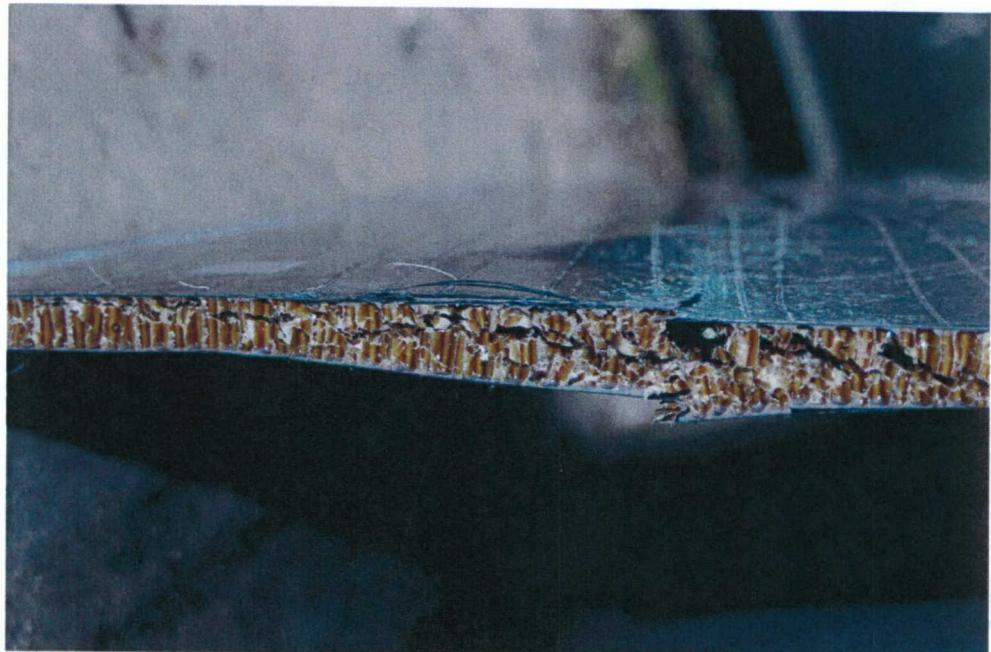
Figure C.4 Severely damaged honeycomb core and teared facings at the end of the main fold (1). Note the green fibres, which are remains of the safety net.

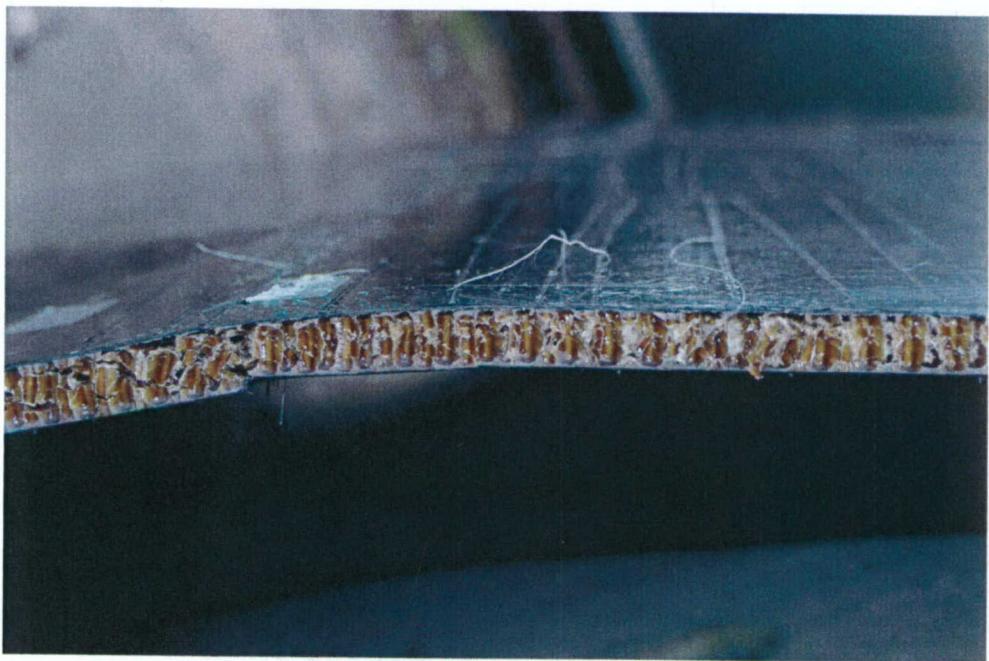
Figure C.6 Severely damaged honeycomb core and teared facing (3).

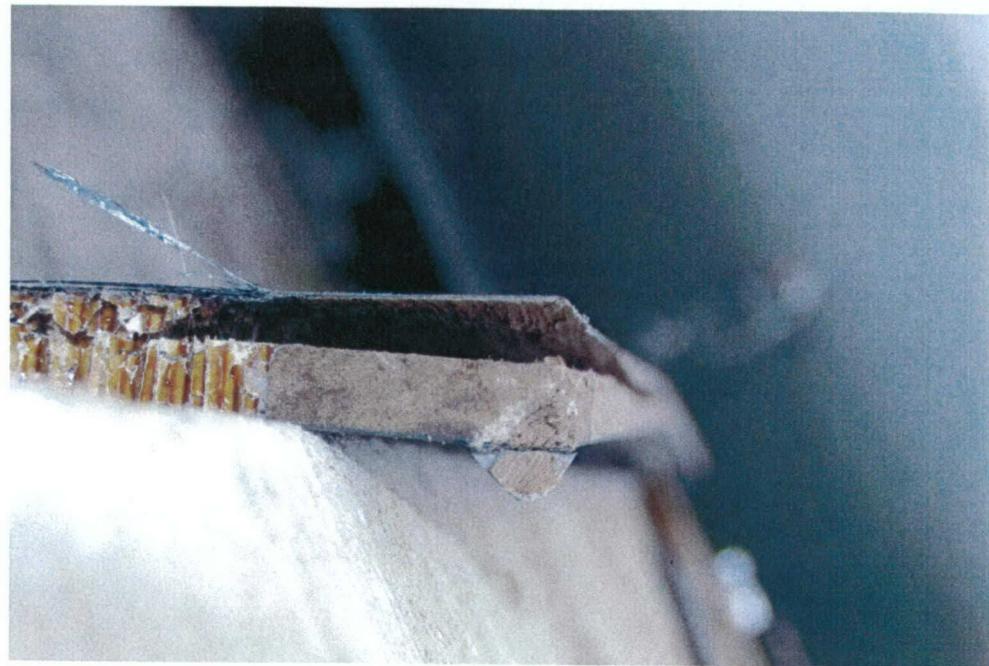
Figure C.7 Delaminated wooden insert and intact facing.
